The Albuquerque Overbank Project

A Model for Large River Riparian Ecosystem Restoration in the Southwest

Esteban Muldavin, Elizabeth Milford, and Nancy Umbreit

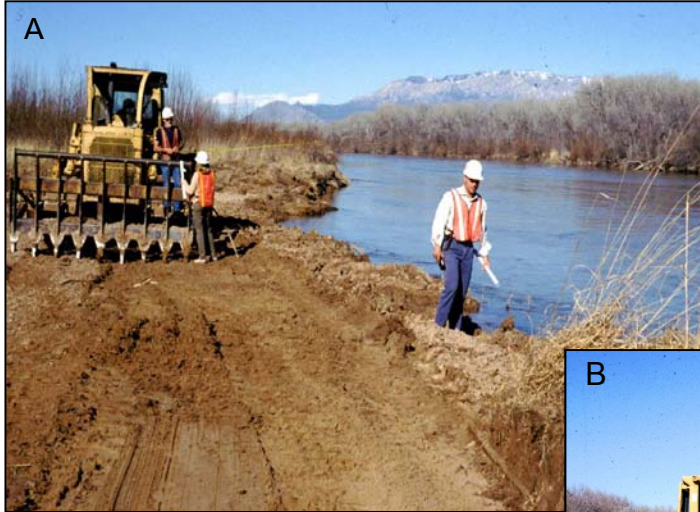
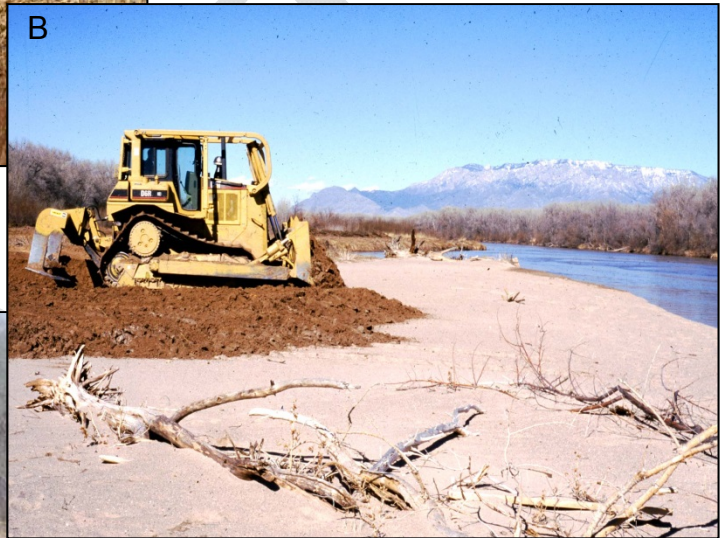
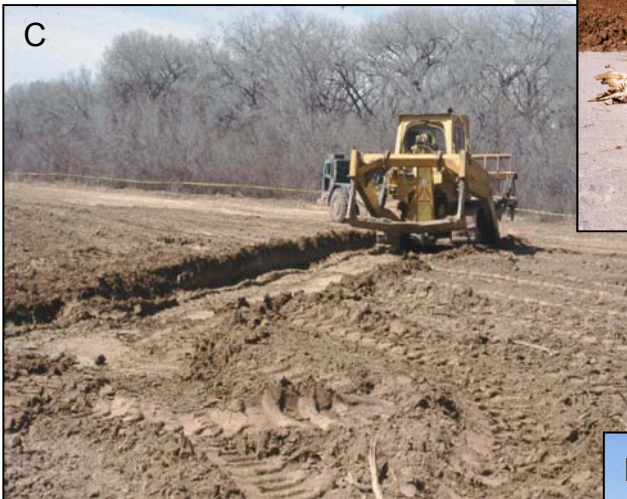
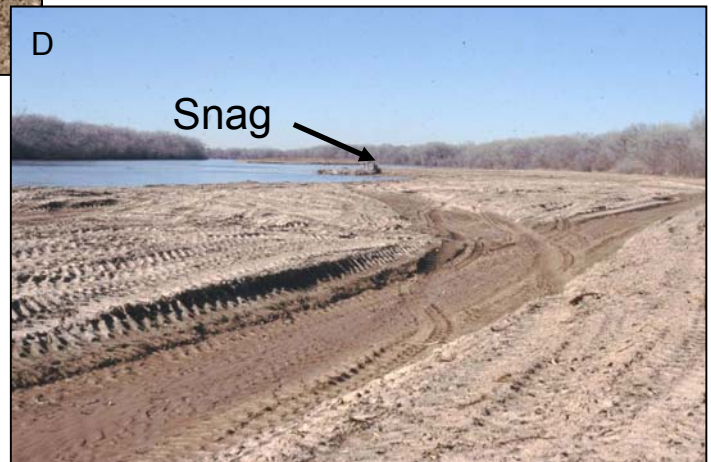
- AOP site construction.

AOP site treatment was begun in March 1998 with the clearing of a Russian olive stand and the lowering of the bar by approximately 0.66 m (two ft) (A). Materials were moved onto an adjacent sandbar downstream (B). Channels and low-lying islands were excavated into the 3 new bar to create microhabitats for cottonwood regeneration (C and D).

On a point bar adjacent to the main channel, dense exotic Russian olive (*Elaeagnus angustifolia*) was removed, a portion of the bar lowered by approximately 1 m to be within reach of typical spring runoff events, and channels and islands constructed to aid the establishment of native cottonwoods, willows, and a diverse assemblage of shrubs, grasses, and forbs. The cost of the manipulation was approximately \$12,350/ ha (\$5,000/ac).

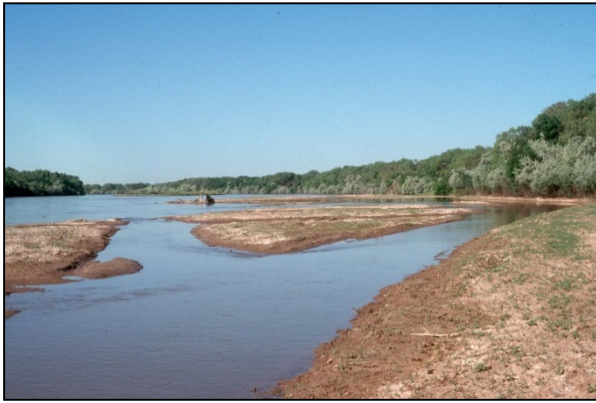
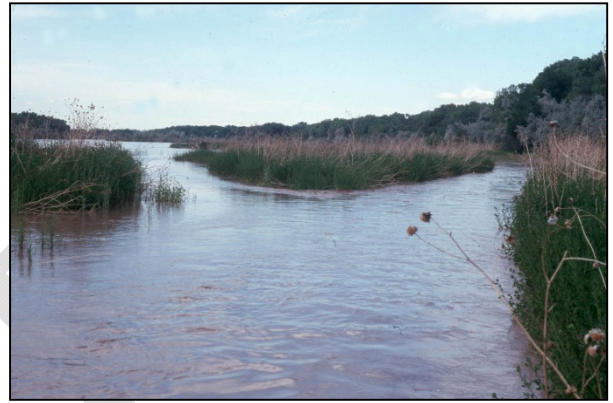
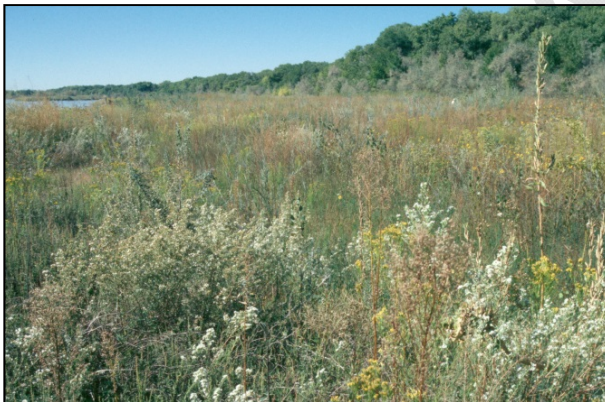
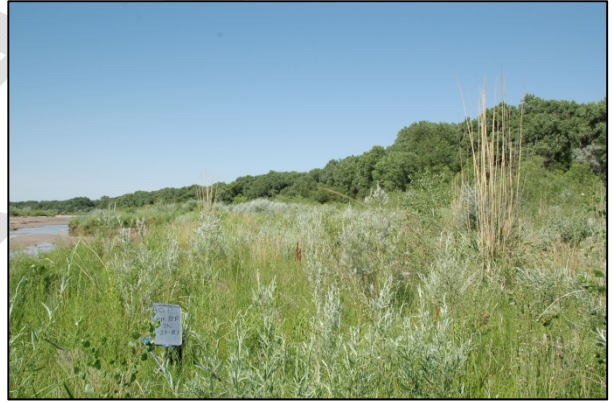
- The upper AOP bar through time; floods ranged from 3,000 to 4,000 CFS.

1998

1999

2003

2007

In 1998, 1999, and 2001, the site flooded during peak discharges between 85 and 113 cms (3,000 and 4,000 cfs) in May through June. After the initial 1998 flood, there was a large germination event of Rio Grande cottonwoods (*Populus deltoides* ssp. *wislizeni*) that resulted in the establishment of 10,070 saplings/ha (4,077/acre) in that year. Through a process of self-thinning due to shading and beaver herbivory, the cottonwood numbers stand at about 2,500 stems/ha (1,000/acre) at the end of 2013. The highest densities of cottonwoods occurred in and along the constructed channels, and to a moderate degree on the island between the channels. Lowest densities were in lower channel areas characterized by deposits of clay sediments, or high salinities, and on an elevated terrace where Russian olive had been removed but not lowered and flooded. In addition, sites on the fill material from the excavation of the bar had little cottonwood recruitment. Hence, cottonwood establishment, while high in some areas, was patchy across the site.

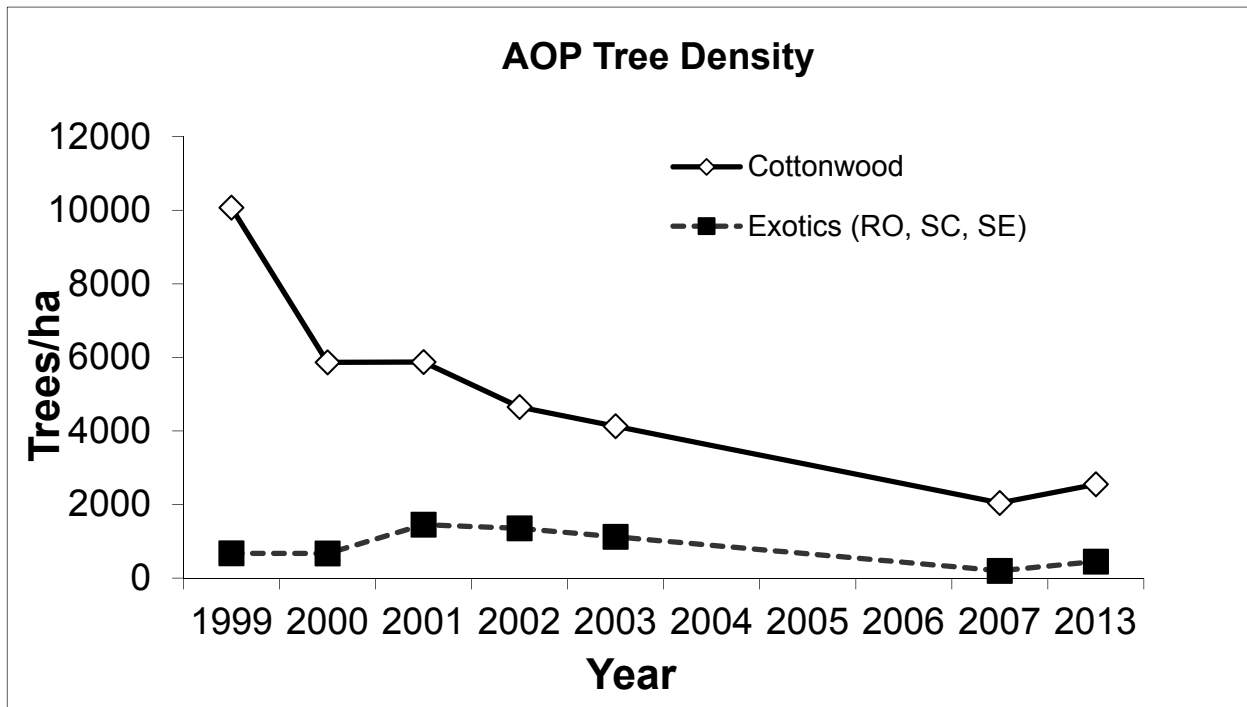
- Cottonwoods dominate the trees, but Russian olive needs periodic retreatment at low levels

Although the site had been cleared, exotic trees Russian olive and salt cedar (*Tamarix ramosissima*) shrubs regrew from root-crown remnants and seed, and were approaching densities of 1,355 stems/ha (550/ac) by the end of 2002. Yet cottonwoods still clearly dominated the site. After 2003, the Russian olives were retreated through cutting and herbicide applications directly to the cut stems. Numbers

dropped to 198 stems/ha (80/ac) in 2007 but have risen to 450/ ha (182/ac) in 2013. This suggests that minor retreatment of exotics will still be needed on a decadal basis.

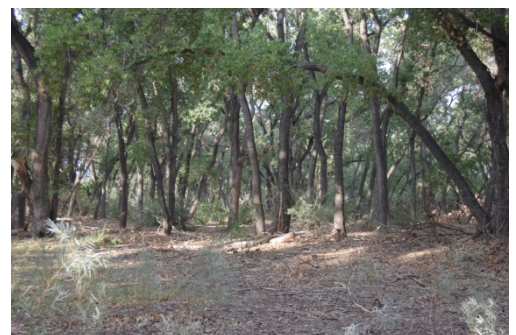
- Beavers are a significant impact on cottonwood growth

Beavers have significantly impacted cottonwood growth and stand development. Nearly half of the established cottonwoods have been browsed by beaver, while only about a third of the exotics, mostly Russian olive, were impacted. Many cottonwoods were killed outright, but most browsed trees are resprouting from multiple stems at the base (the majority also remain less than 2m (6 ft) in height). The key is whether densities will be high enough through time to allow the development of a forest without some beaver protection.

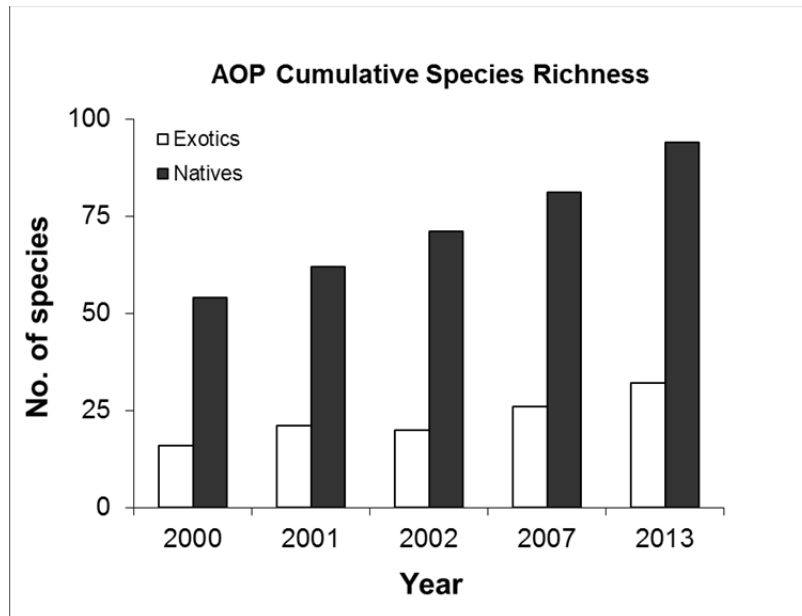
- Plant species diversity is high and dominated by natives

Species diversity was also much higher compared to the forest. Cumulative species richness has continued to increase over the 15 years, and 126 plant species have been recorded so far, of which 75% were native. But canopy cover of exotic grasses had become a significant issue by 2013, with nearly half the graminoid cover dominated by introduced species, particularly reynougrass (*Saccharum ravennae*), a Class A noxious weed. Approaches to the latter's control are becoming an important issue in Rio Grande restoration.

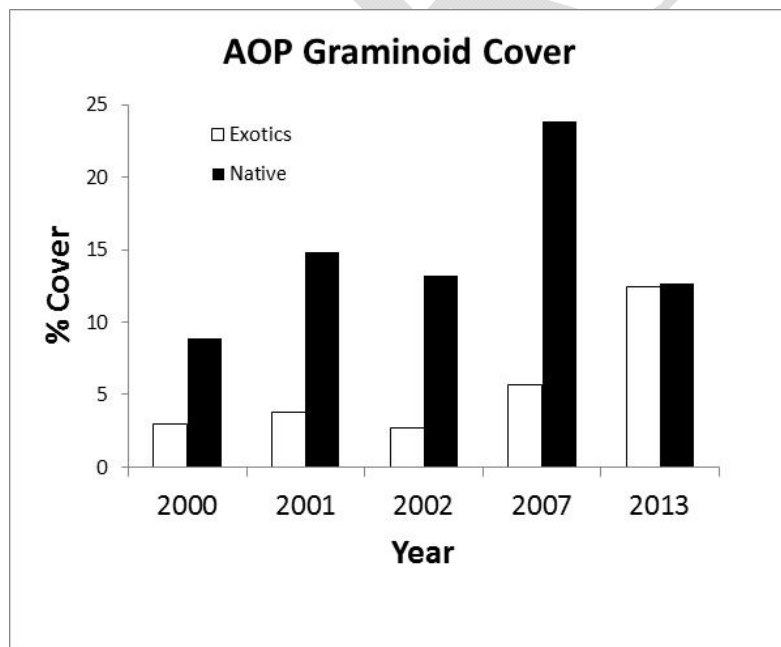
- Exotic grass cover is becoming a problem

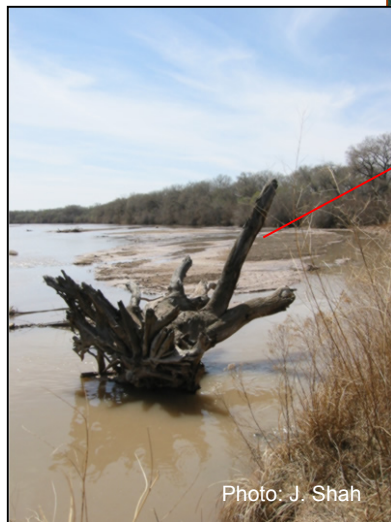
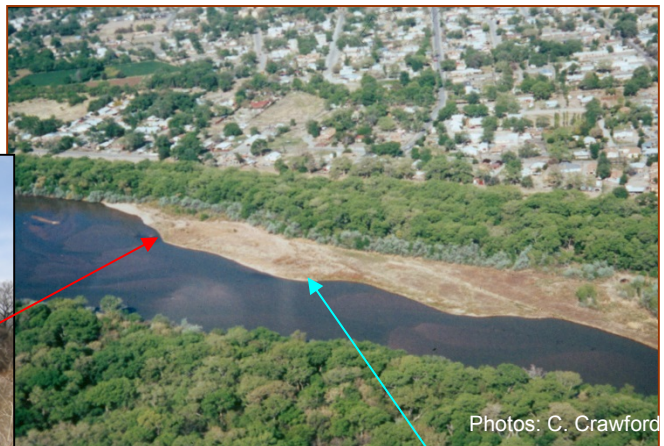
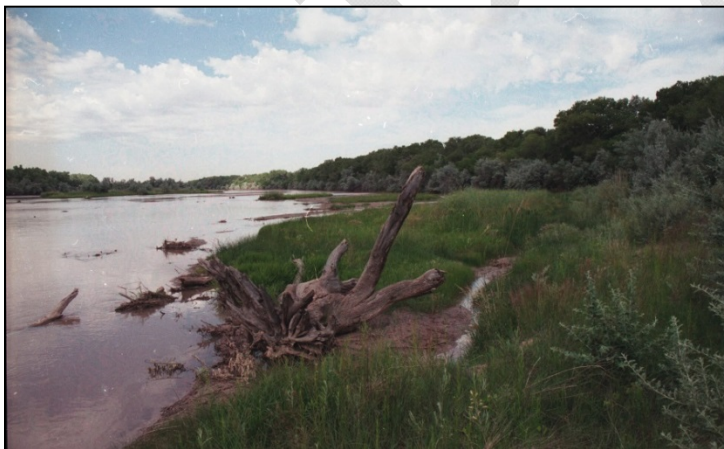
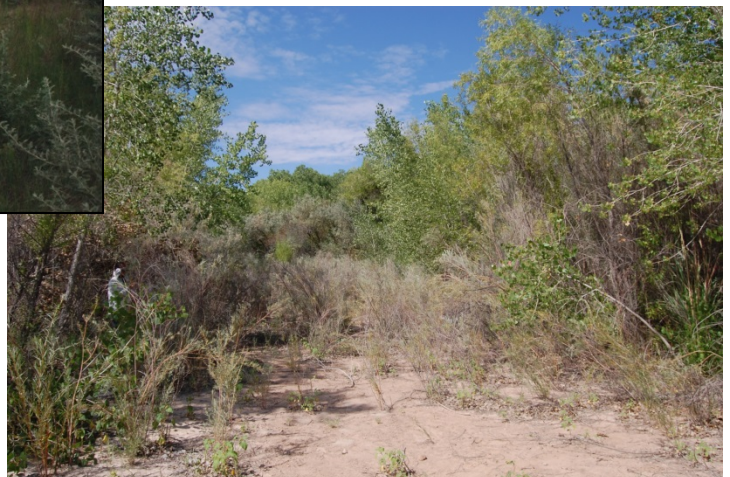
- Large Woody Debris (LWD) matters; behind new sand bars form and subsequent vegetation patches.

The construction of topographic features such as channels and islands and overbank flooding led to increased vegetation patch diversity. By 2013, there were over 10 different tree, shrub, and herbaceous patch types compared to the nearly uniform adjacent mature sparse forest. Large woody debris can also play a key role in increasing patch diversity and fostering cottonwood reproduction. For example, a large stump became logged at various locations along the channel edge creating sand bars behind it that were followed by the establishment of new willow and cottonwood stands.
