BOSQUE ECOSYSTEM MONITORING PROGRAM (BEMP) SITE MONITORING REPORT FOR 2016

2016 ANNUAL SITE MONITORING TECHNICAL REPORT

Submitted July 5, 2017

USACE Solicitation Number: W912PP-15-C-0036, Option 1

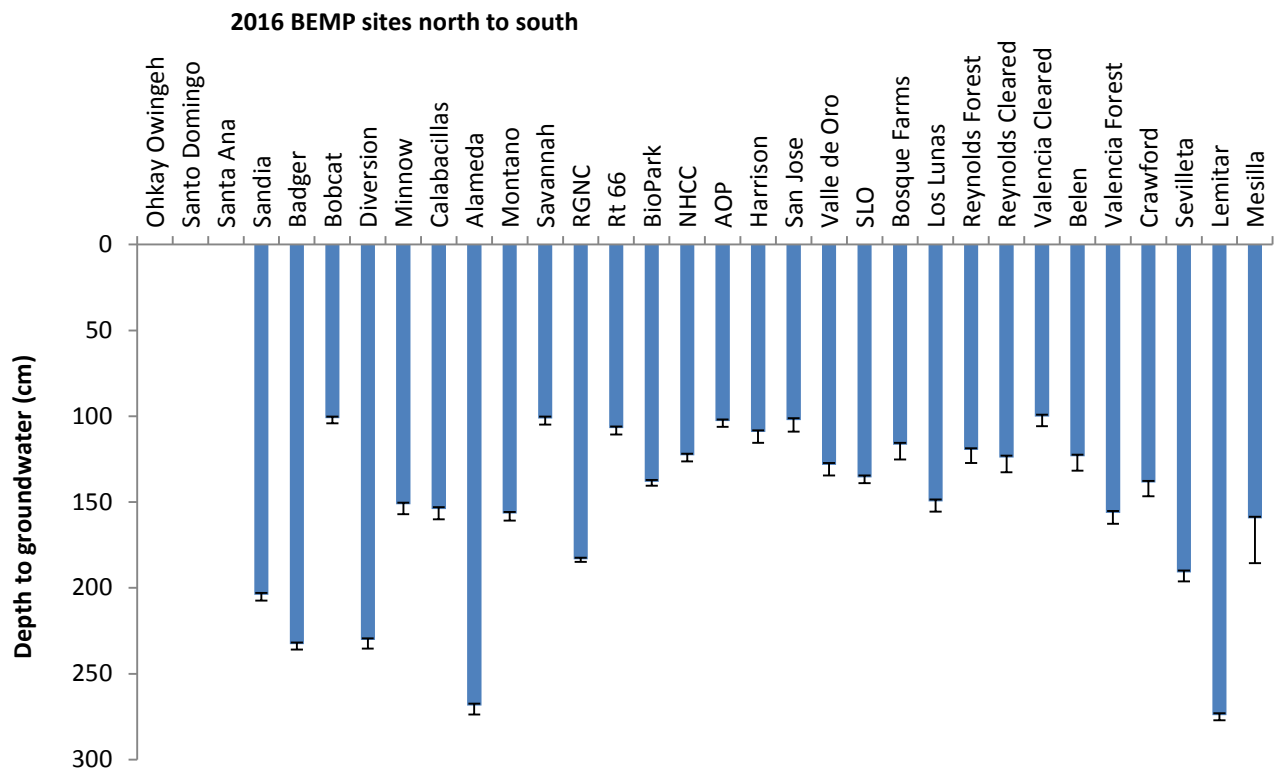
Figure 3. 2016 mean depth to groundwater (cm) at BEMP sites from north to south.

Depth to groundwater did not vary much within most sites (Figure 3). Overall, river flows were lower in 2016 (Figure 4), resulting in lower groundwater levels at individual sites. The strong connection between river flow and groundwater level is apparent when examined across BEMP sites using an overall mean to compare the two variables (Figure 4).

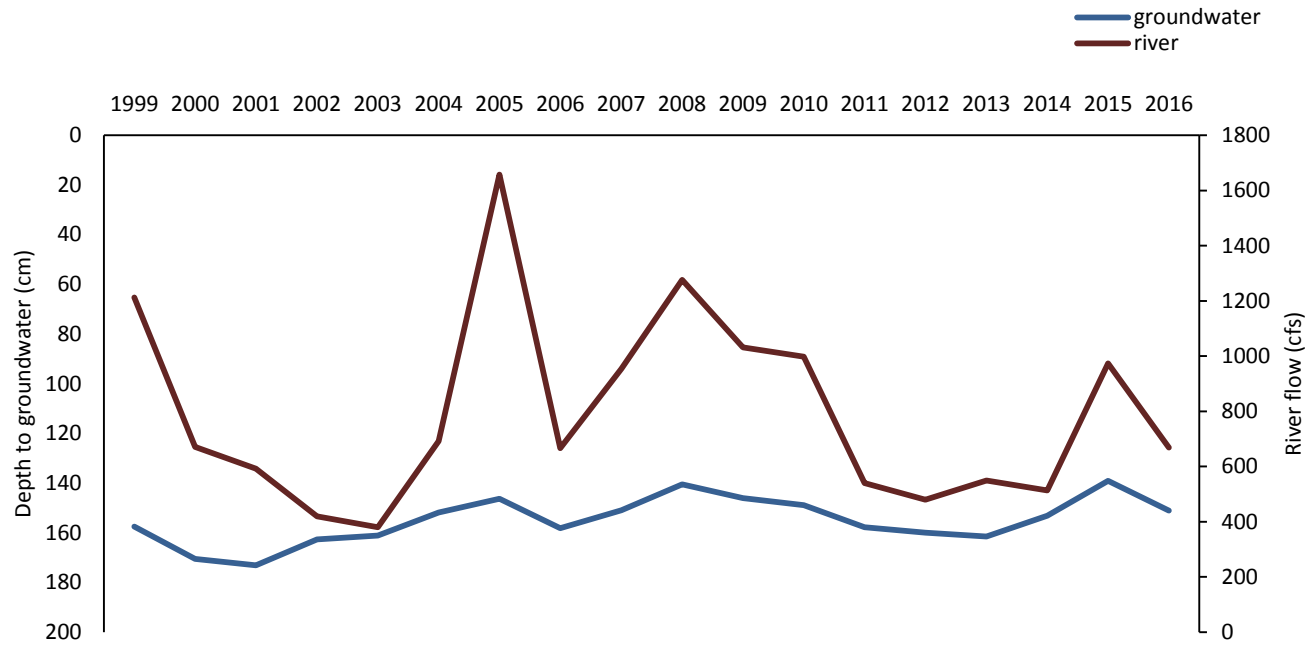
Figure 4. Mean annual depth to groundwater and mean annual river flow across all BEMP sites

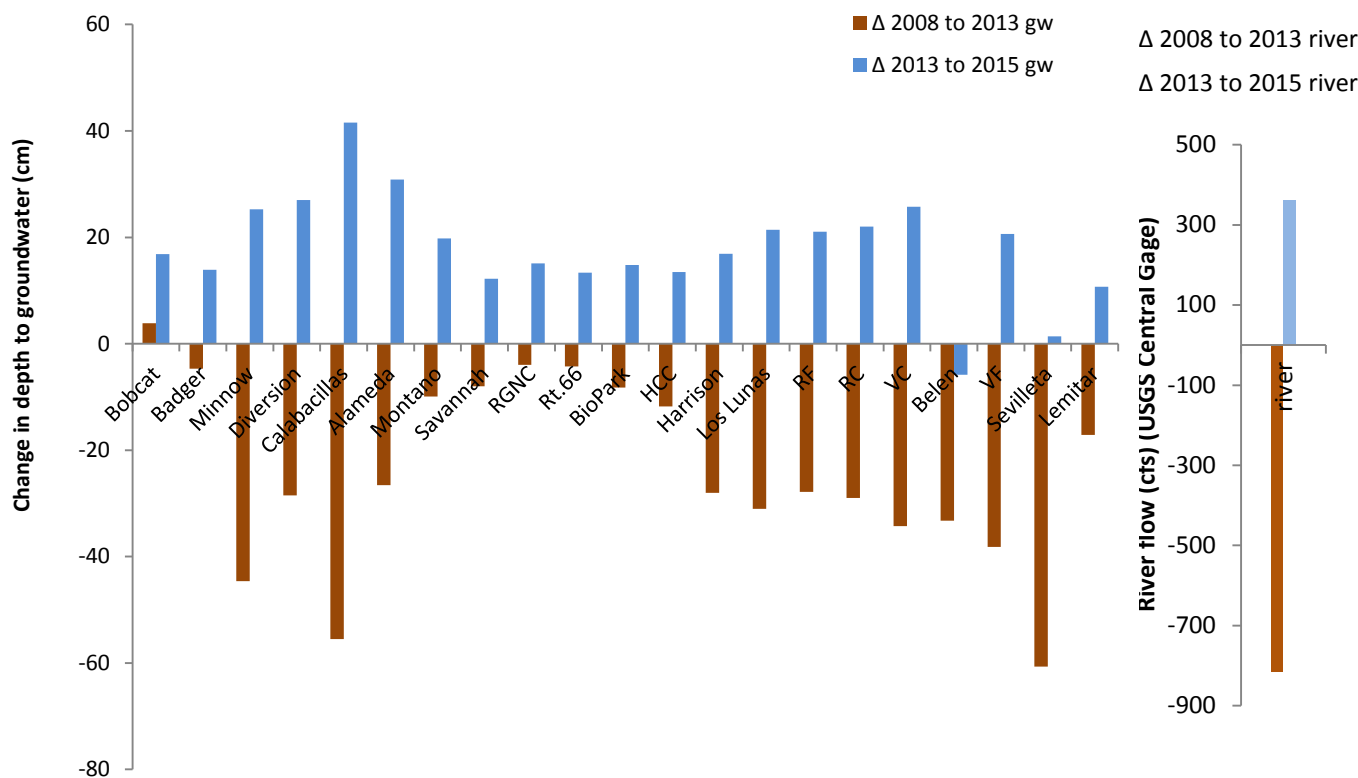
Figure 7. Change in depth to groundwater (cm) during drought years (2008-2013) and recovery years (2013-2015), as compared to the change in river flow during the same time frames.

Due to drought and river drying during 2008-2013, groundwater depth decreased at all but one BEMP site; the exception was directly above the Drinking Water Diversion Dam in Albuquerque (Figure 7). From 2013 to 2015 there was an increase (or “recovery”) in river flow, which resulted in an increase/recovery in groundwater levels at most sites (Figure 7). The only site to continue to experience a decline in groundwater levels was the Belen BEMP site, near the Willie Chavez State Park; however, adjacent sites did show recovery of groundwater levels.

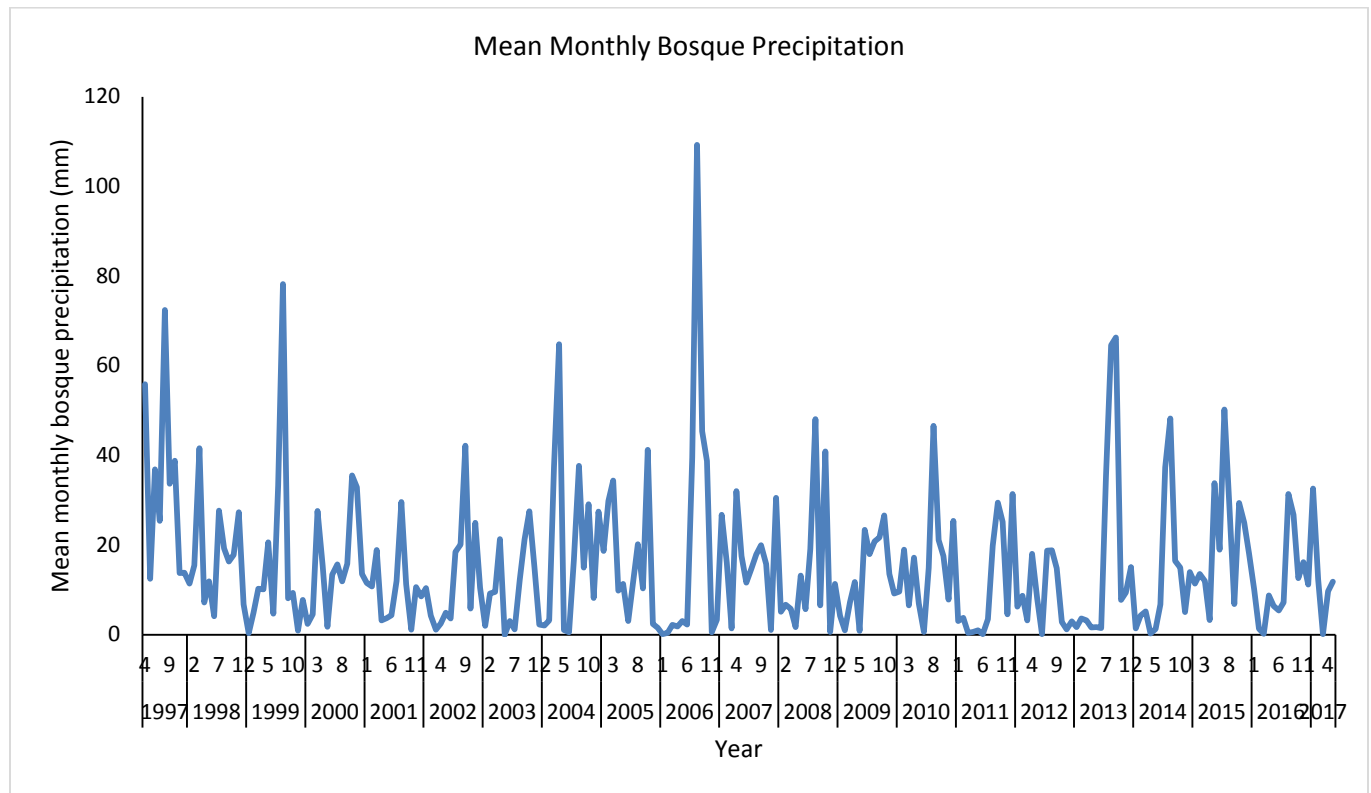
Figure 8. Precipitation averaged across all sites for each month.

Most precipitation peaks in the Middle Rio Grande occur in August (Figure 8). 2016 was a below-average rainfall year (Figure 9).

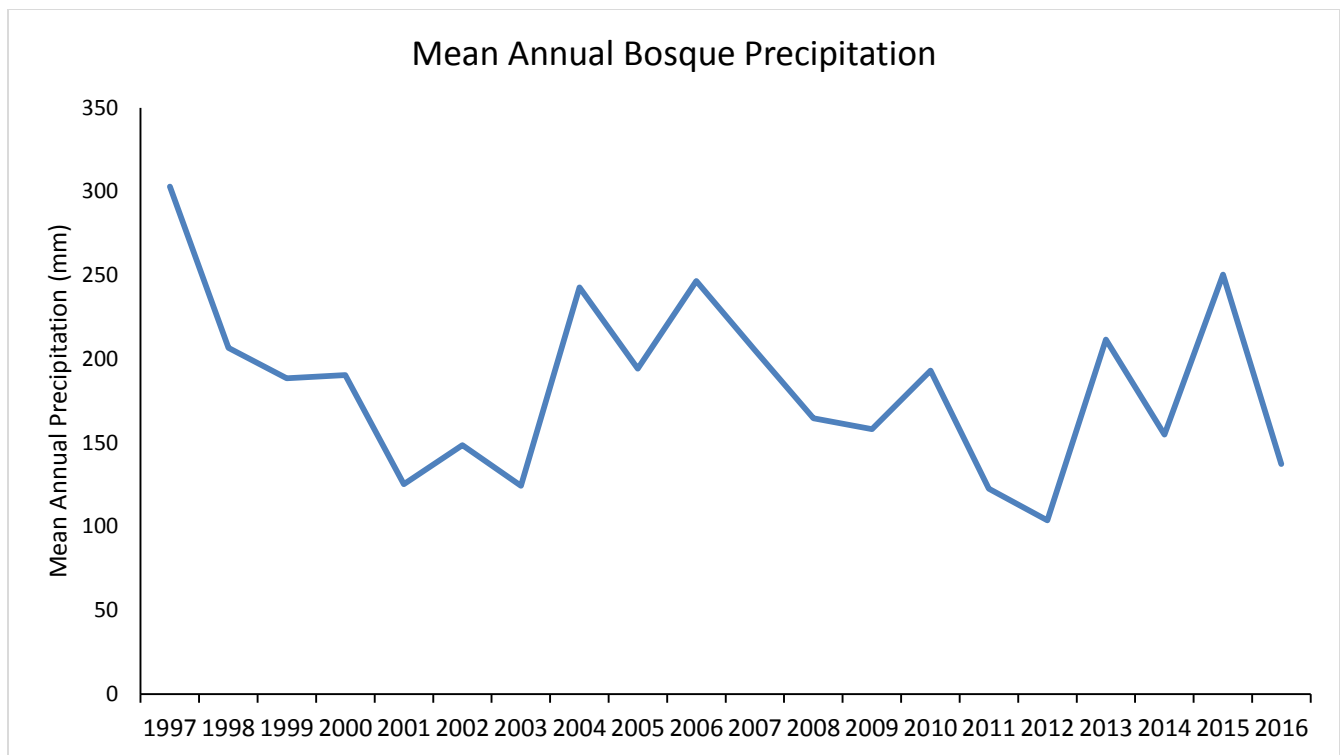
Figure 9. Mean annual bosque precipitation (mm), averaged across all BEMP sites.

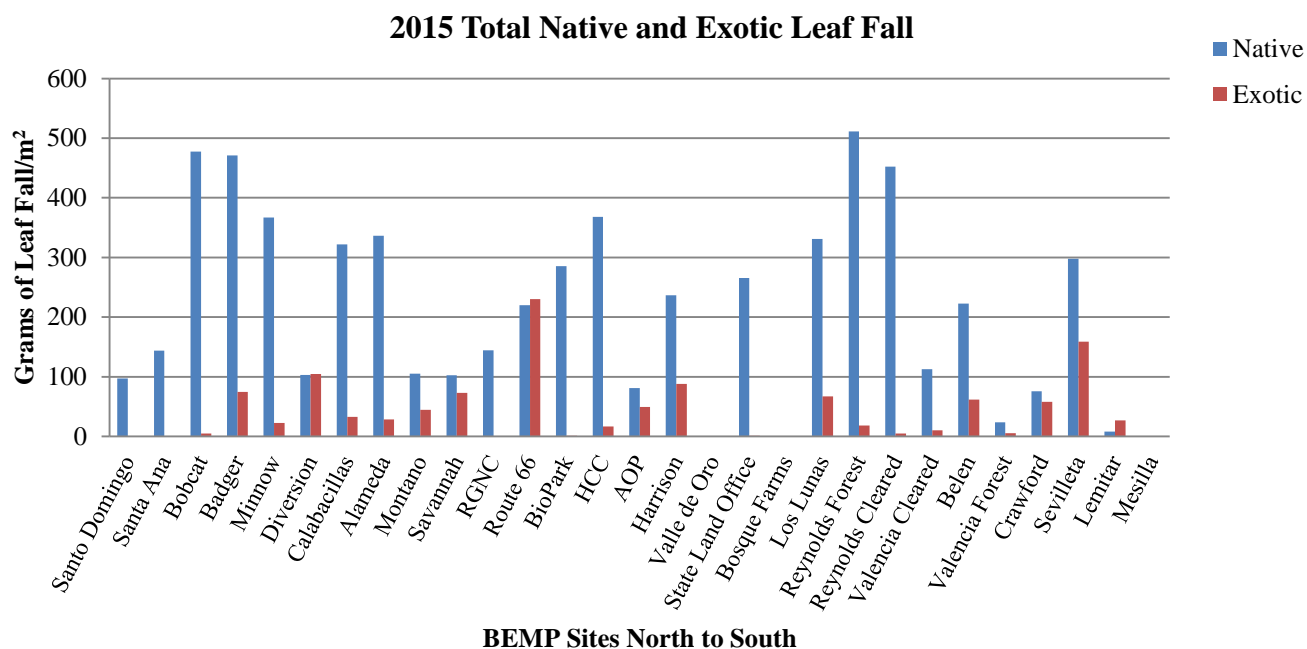
Figure 10. Total native and exotic leaf litter fall in grams, at 29 BEMP sites in 2015. The Bosque Farms site was not monitored in 2015 and the lack of data should not be construed as zero leaf fall.

Native species comprise the vast majority of leaf fall collected all but two sites: Diversion and Route 66 (Figure 10). Cottonwood accounts for the vast majority of total native leaf fall and as well as total leaf fall at most of our sites (Figure 11). Cottonwood comprises the majority of reproductive litterfall at most sites (Figure 12). The majority of sites have senescing cottonwoods (as seen in Figure 14, vegetation cover), and this can clearly be seen at the Santa Ana site where cottonwoods have been rapidly dying off (Figure 13).

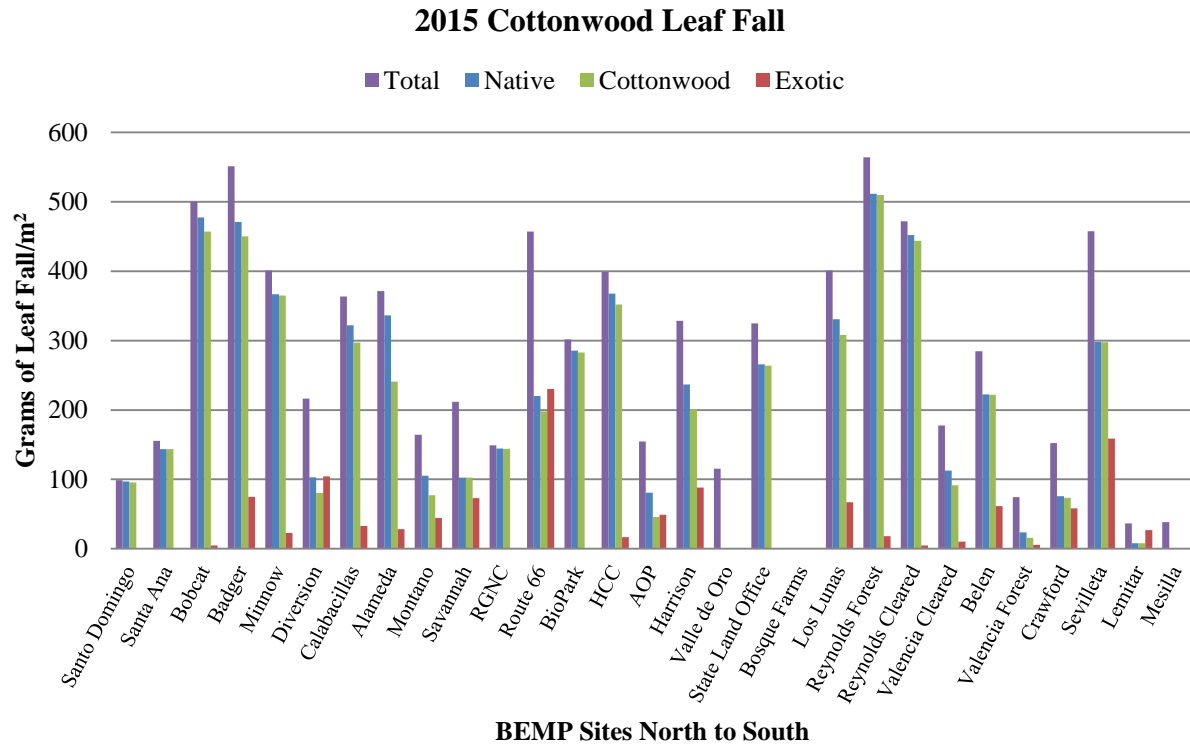
Figure 11. Total cottonwood leaf fall in grams/m², as compared to total leaf fall, total native leaf fall, and total exotic leaf fall, at 29 BEMP sites in 2015. The Bosque Farms site was not monitored in 2015 and the lack of data should not be construed as zero leaf fall.

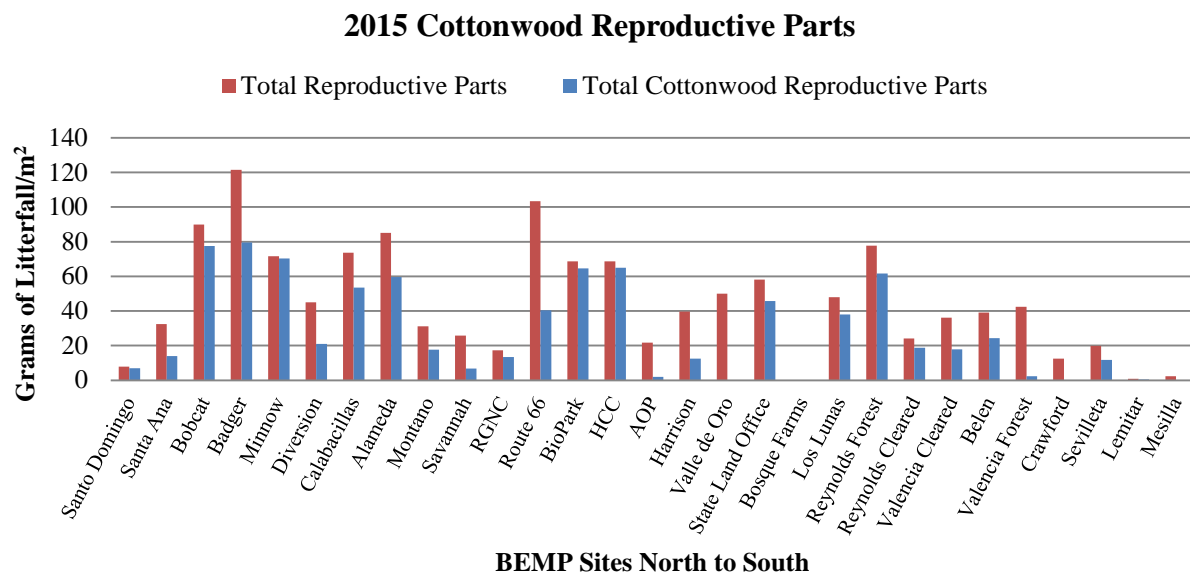
Figure 12. Total litterfall of cottonwood reproductive parts at 29 sites, as compared with total reproductive litterfall. The Bosque Farms site was not monitored in 2015 and the lack of data should not be construed as zero litterfall.

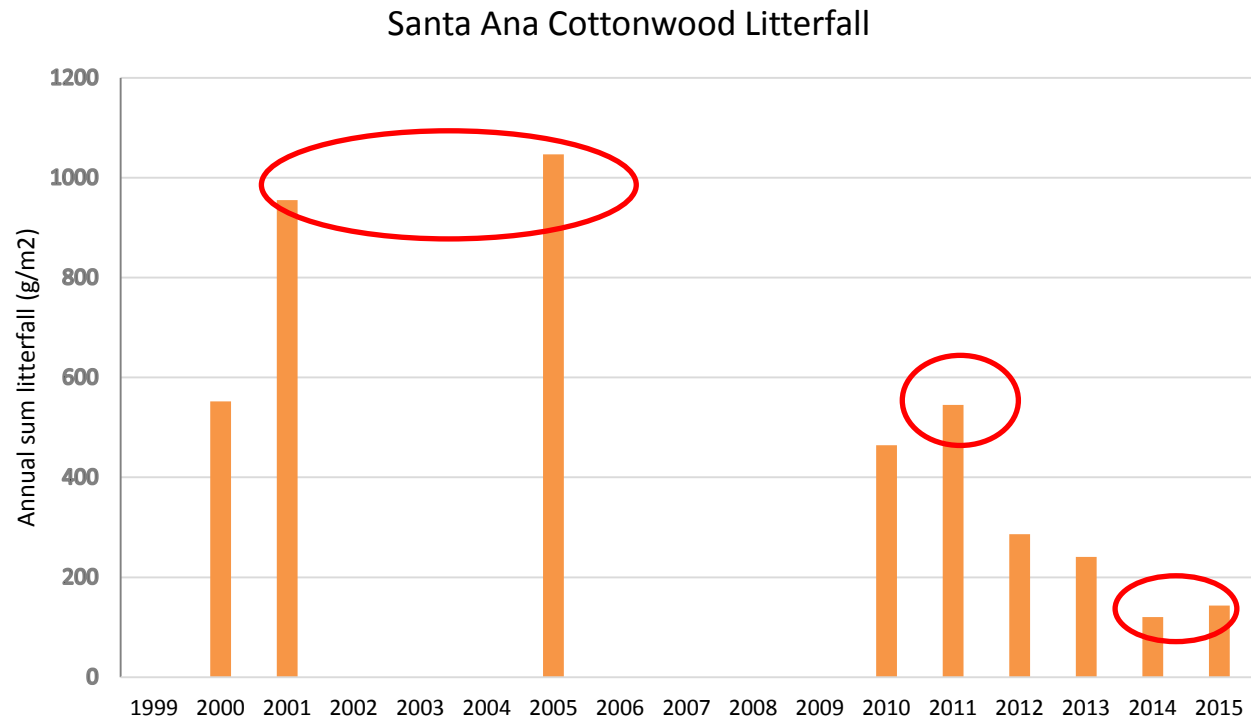
Figure 13. Cottonwood litterfall at the Santa Ana BEMP site. Years with missing data had more than 3 months of data missing, and so sums for those years are not representative of the full year. Red circles indicate significant differences.

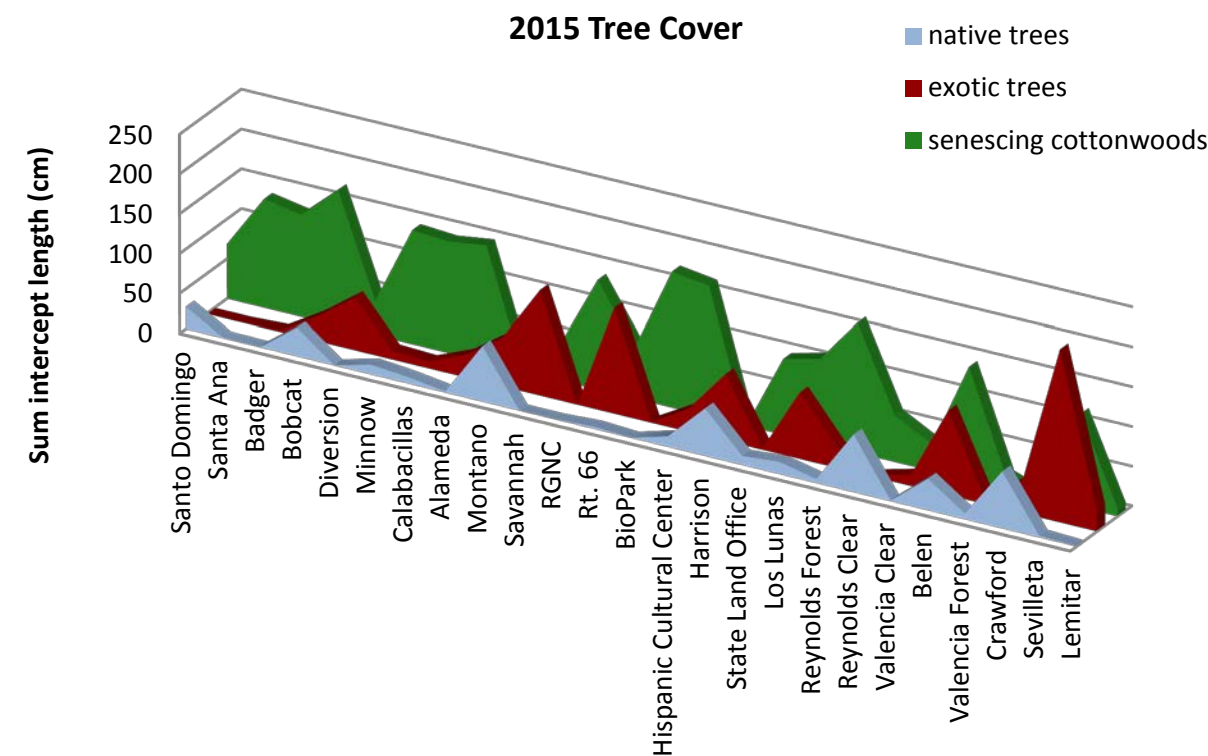
Figure 14. Dominant tree cover at BEMP sites, divided into senescing cottonwoods (green), native trees (mostly willows and young cottonwoods) (blue), and exotic trees (Russian olive, saltcedar, and Siberian elm) (brown).

In response to dropping groundwater levels, senescing cottonwoods have experienced limb or tree mortality. The majority of cottonwoods at BEMP sites (and in the Middle Rio Grande Valley generally) are senescing (Figure 14), and they form the dominant cover. Based on current cover, it appears these cottonwoods will be replaced by exotic species, mostly Russian olive and tamarisk, with some Siberian elm (Figure 14).

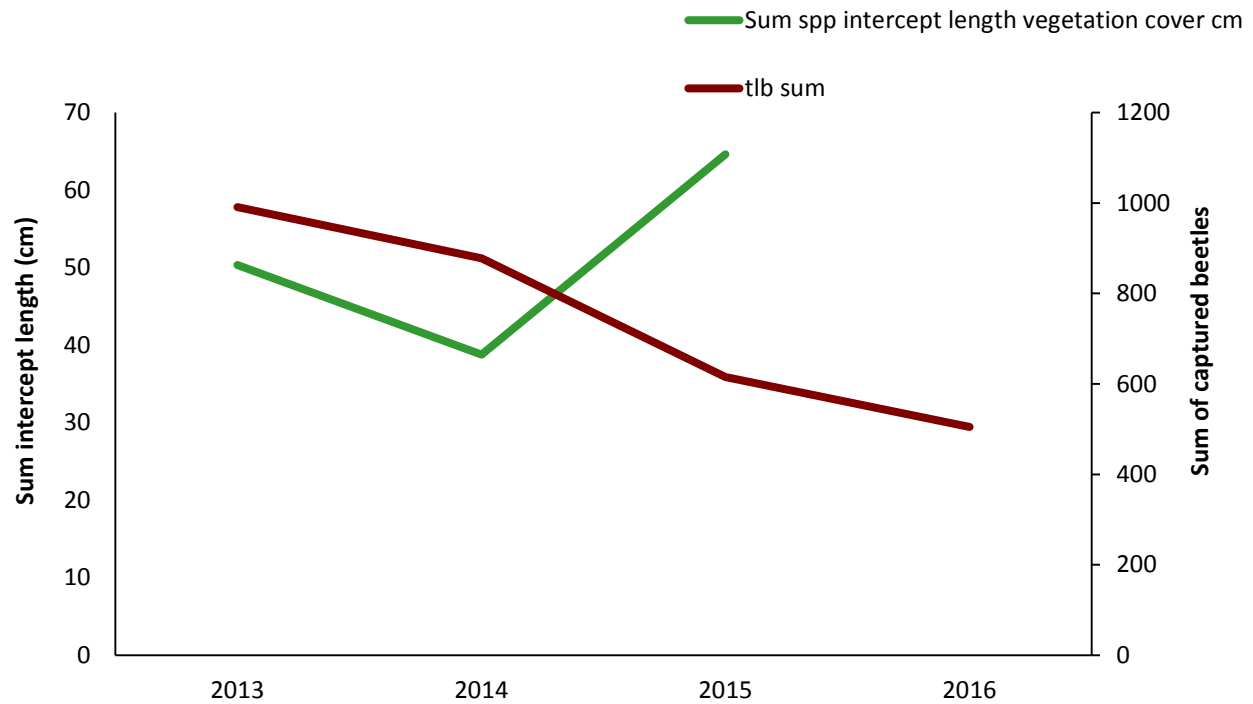
Figure 16. Abundance of tamarisk leaf beetle and saltcedar cover in BEMP sites from 2013 to 2015.

Preliminary data show that in spite of the introduction of the tamarisk leaf beetle, saltcedar cover at our sites has recovered after an initial decrease (Figure 16). Large-scale defoliation is still notable and is documented in our photo record for each site. Continued monitoring will indicate the efficacy of the beetle in controlling saltcedar. BEMP also monitors two other tamarisk defoliators present in the bosque: the splendid tamarisk weevil (*Coniatus splendidulus*), and the tamarisk leafhopper (*Opsius stactocalus*) (Figure 17). The tamarisk leafhopper was present in greater numbers than the tamarisk leaf

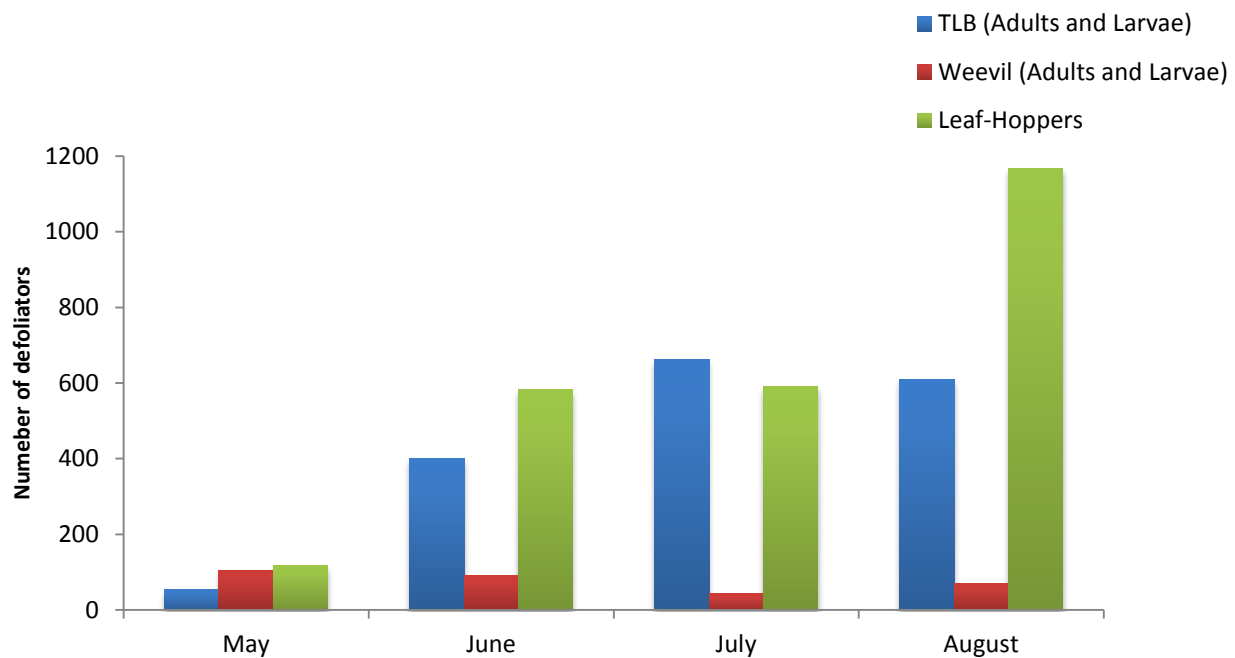
Figure 17. Total number of saltcedar-specific defoliators (tamarisk leaf beetles (TLB), splendid weevils, and leaf-hoppers) by month in 2016.

beetle in all months but July, though large-scale defoliation can be attributed to the tamarisk leaf beetle only. The two insects consume different parts of the leaf, resulting in distinct coloration and pattern of defoliation that can be verified via our photo record. (Figure 17).

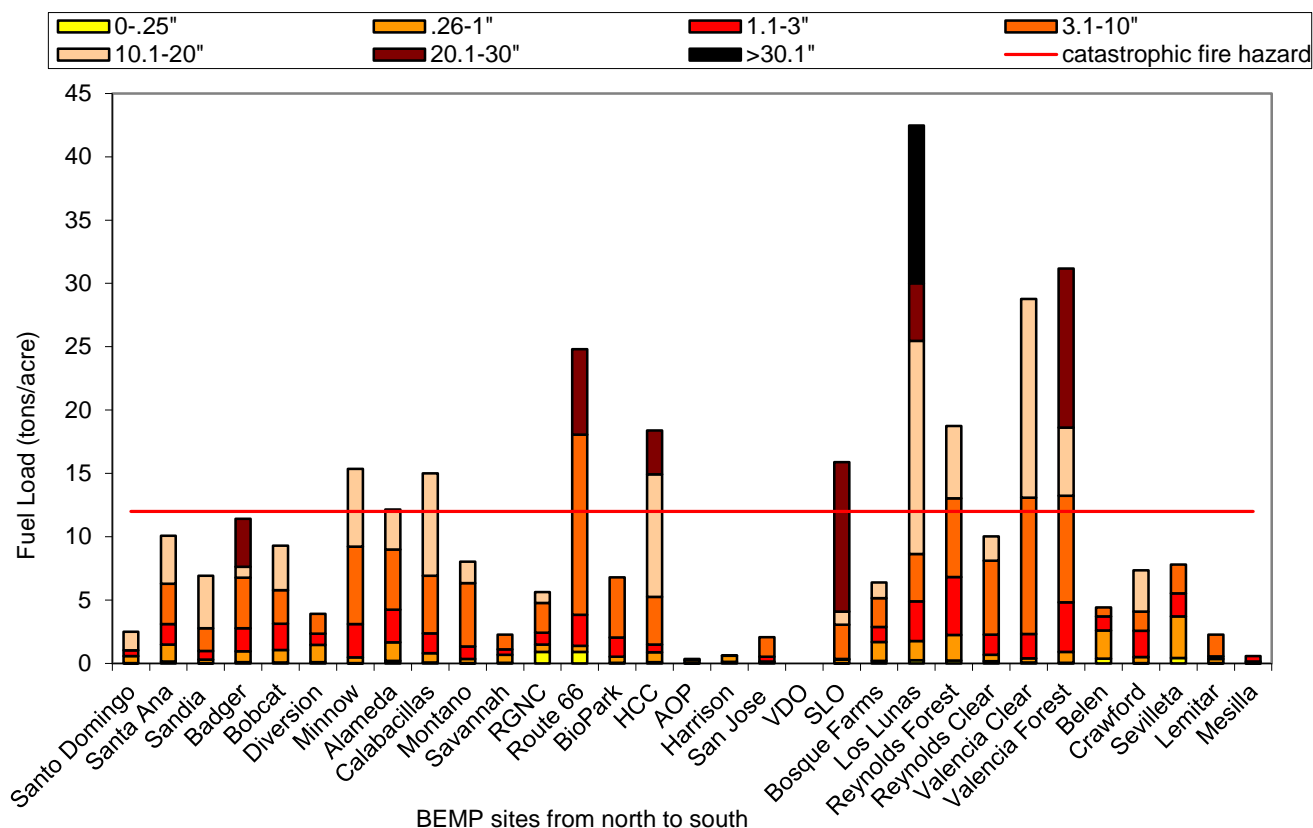
Figure 18. 2016 fuel load at BEMP sites. The tons per acre calculations are broken down into categories based on the size class of the wood. The red trend line indicates catastrophic fire hazard fuel load (12 tons per acre).

Woody debris sampling is conducted each year at 17 Albuquerque sites, and at all 31 sites every 3 or 4 years (contingent on funding). All sites were sampled in 2016 (Figure 18). BEMP has produced fuel load maps of this dataset that also display other dimensions of fire risk at our sites, including large amounts of small-diameter fuels, high foot traffic, and ease of access (Figures 19 & 20). We hope that these maps will help managers to identify areas of heightened fire risk for monitoring or intervention.

catastrophic fire hazard = 12 tons/acre

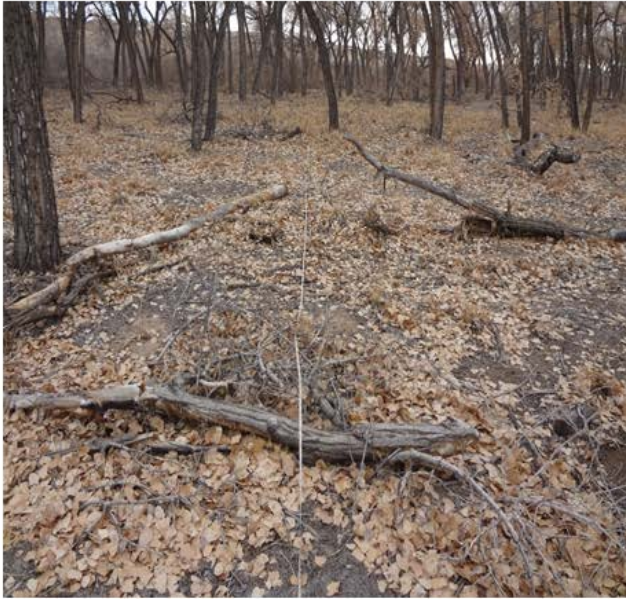
LOW-MOD FUEL LOAD

High foot traffic / easy access

Moderate fuel load (5.6 tons/acre)

Site Location: Rio Grande Nature Center State Park

Photo comparison of low fuel load and high fuel load sites.

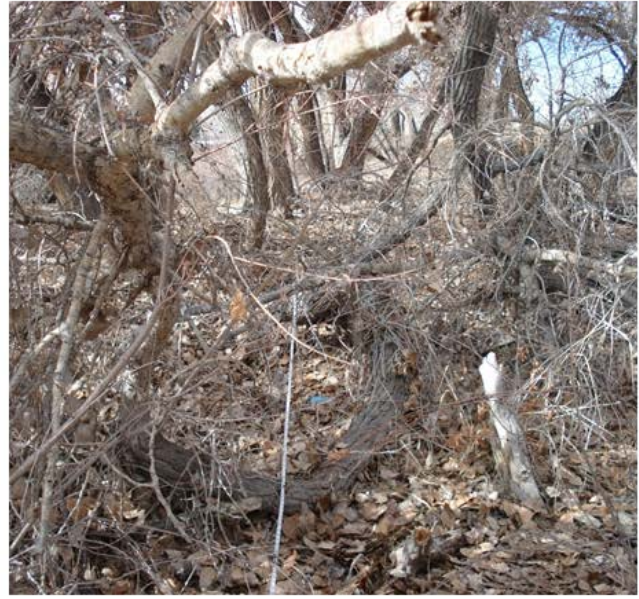
HIGH FUEL LOAD SITE

High foot traffic / easy access

High fuel load (14.4 tons/acre)

Site Location: South of Alameda Bridge, Bobcat

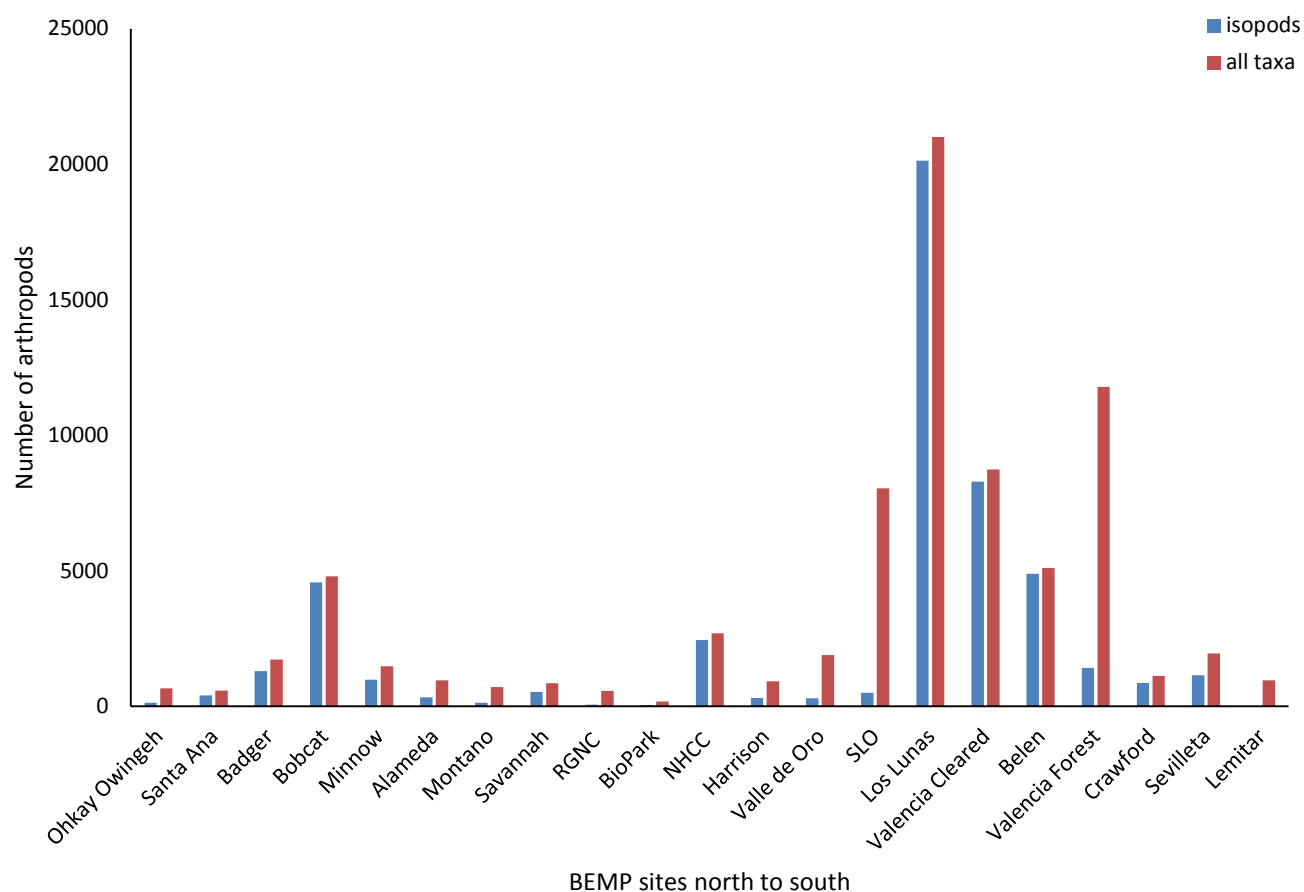
Figure 21. 2015 annual sum of arthropods (all taxa) and isopods captured in pitfall traps at BEMP sites.

The annual sum of abundance for sites in 2015 show the highest abundances at many of our wetter sites: SLO (reconstructed wetlands and swales), Los Lunas, and Belen (VC, Belen, and VF), although not all sites in Belen (Figure 21). Although Ohkay Owingeh is a wetland site, it had a low total of arthropods captured (Figure 21). Overall, isopods tend to dominate, representing over 50% of the arthropods caught across all sites (Figure 21).

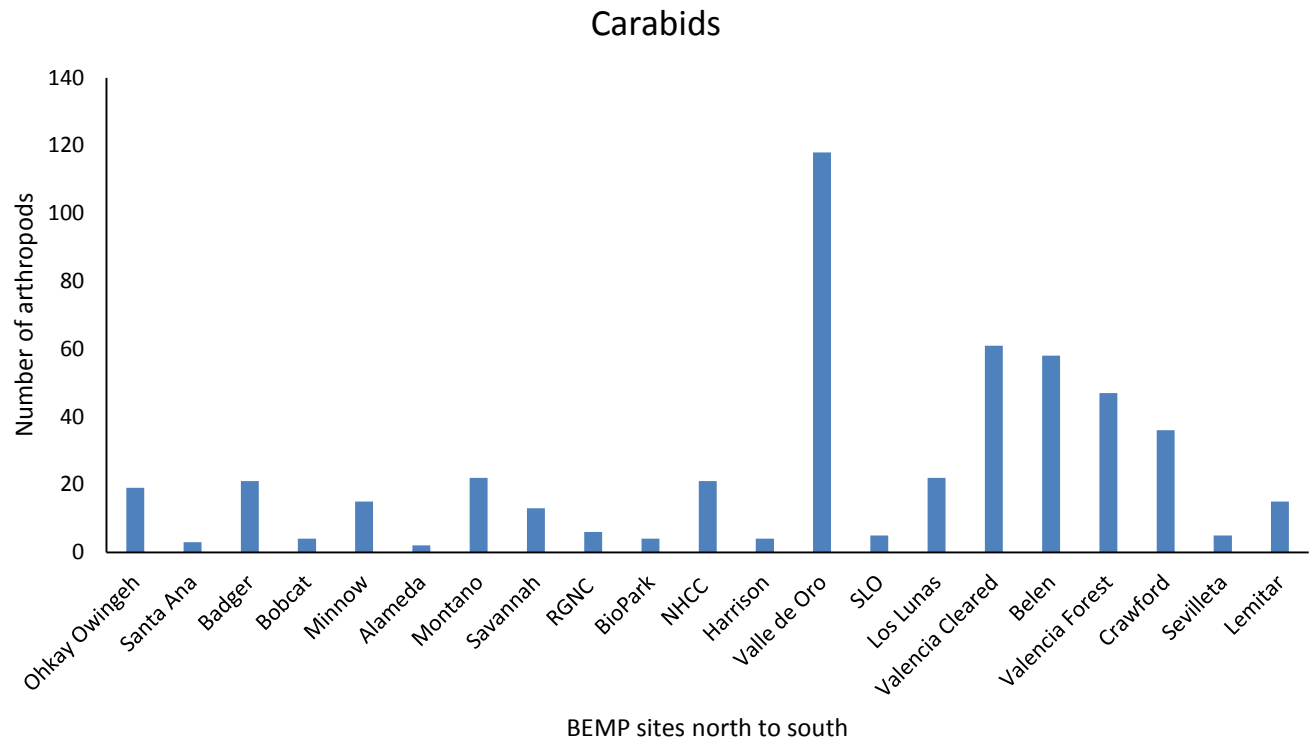
Figure 22. 2015 annual sum of carabid beetles captured in pitfall traps at BEMP sites.

Carabid beetles (or ground beetles) can be environmental indicators of wetter habitat conditions. Carabid beetles represent only 6% of the total arthropods captured in 2015, and are predominantly found at sites south of Albuquerque (Figure 22).
